Manhole Inspection Summary

Manhole # S39I__021MH

Insp Date: **3/27/08 2:38 PM**

Location Address: **slemmers alley**

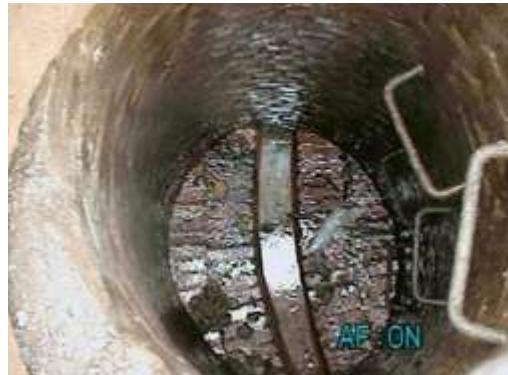
Top View

Comments **There is a steady flow of water from top of frame on one side and infiltration all around manhole**

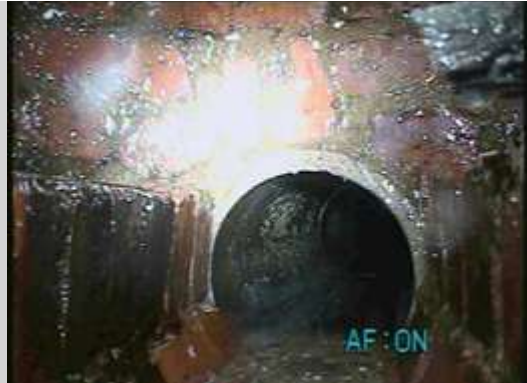
12 O'Clock Outflow

8 in. Circular Gravity Sewer
Pipe Out @ 12 O'Clock

Invert Depth: **8.66** (ft.) Flow Characteristics: **Fast**

Infiltration: **None** Pipe Seal Cond: **Unknown**

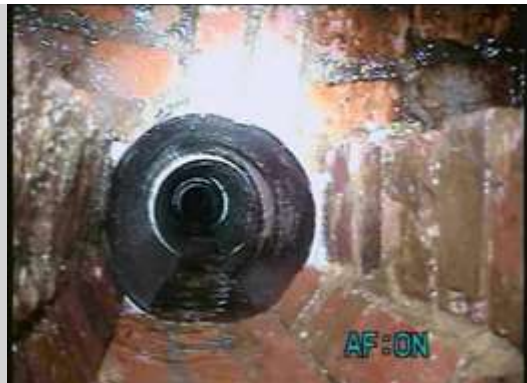
6 O'Clock Inflow

8 in. Circular Gravity Sewer
Pipe In @ 6 O'Clock

Infiltration: **None** Pipe Seal Cond: **Unknown**
